Project Name: Honokahau SBH 1.

2. Date of Inspection: 13 May 2004

# O & M INSPECTION REPORT FOR NAVIGATION PROJECTS Honolulu Engineer District CEPOH-EC-T Honokahau04rpt-ddh.doc

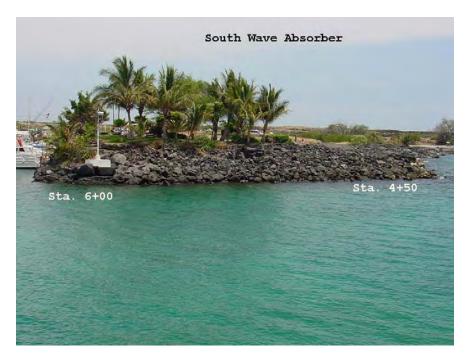
a. South Wave Absorber, Overview

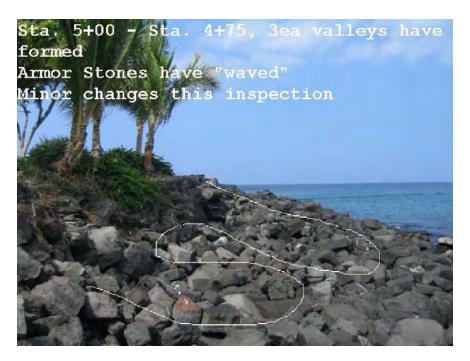
b. Sta. 5+75; Sta. 5+20 and Sta. 4+90, armor stones have been pushed up by wave action, these irregularities in the armor stone

layer causes a  $2^{\prime}$  mound and associated  $2^{\prime}$  depression in the

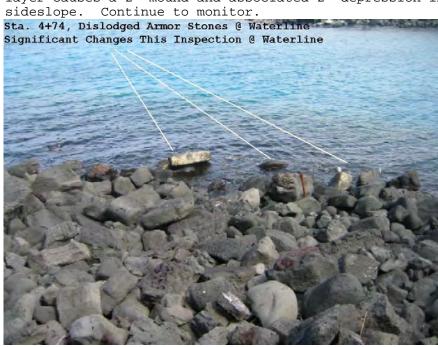
c. Sta. 4+75, armor stones are dislodged at the toe and have caused a void at the waterline.

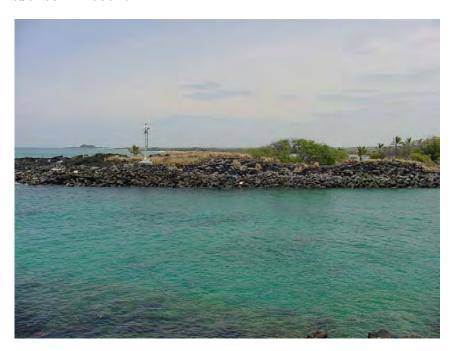
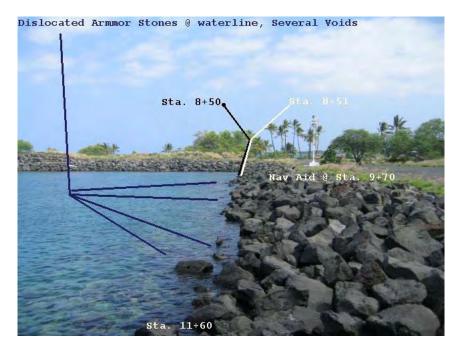
a. Sta. 11+60 thru Sta. 8+51, numerous toe armor stones are displaced at the waterline, some voids.

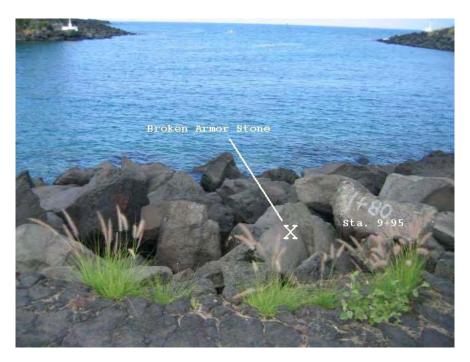
b. Sta. 9+95, dislodged armor stone at the toe. (Sight movement from last inspection).

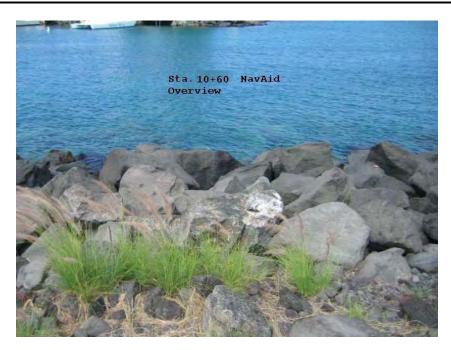
c. Sta. 10+60, Overview from NavAid.

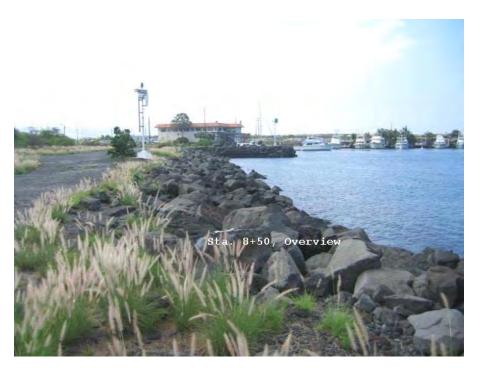
d. Sta. 8+51, Overview (east-side).

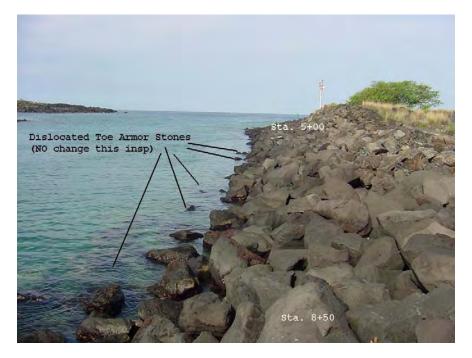
d. Sta. 8+50 - Sta. 5+00, (north-side), dislocated toe armor stones. (No change this inspection)

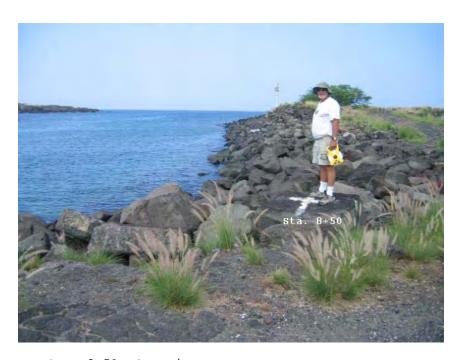
e. Sta. 8+51, Overview

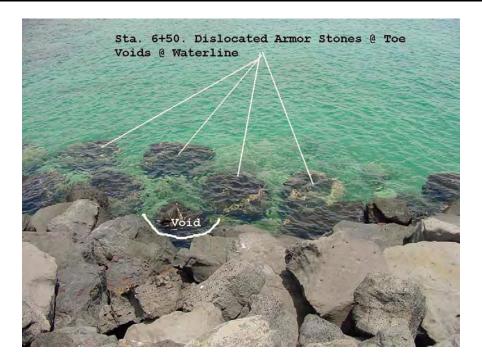
f. Sta. 6+50, displaced armor stone resting adjacent toe.

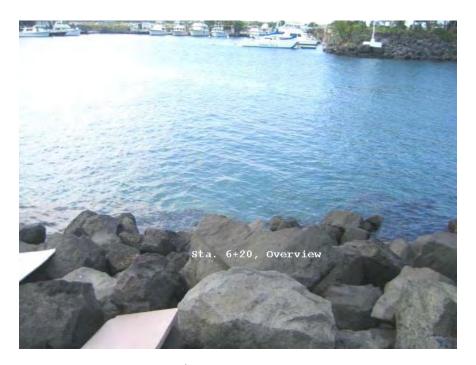
g. Sta. 6+20, Overview reference photo.

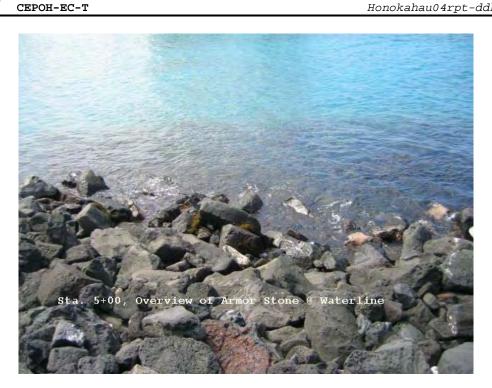
h. Sta. 5+00, Overview of armor stone placement at waterline, no change.

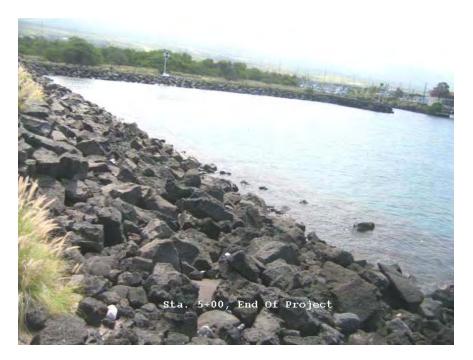
i. Sta. 5+00, Overview facing Sta. 8+51
